HOME INSPECTION REPORT

**3001 N. Torreys Peak Drive
Superior, Colorado 80027**

Inspection Date:
8/4/2010

Report Number:
0604101

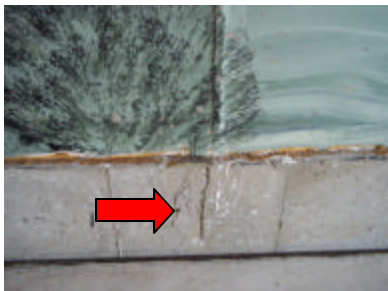
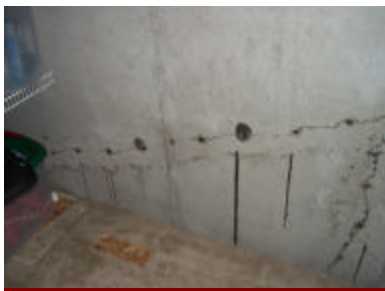
Prior Foundation Repair

- **Monitor:** Prior repairs were noted to the foundation on the entire home. Consult the Seller as to when and what repairs became necessary. Multiple documents are available for review if desired. A Structural Engineer could be consulted to further evaluate this condition and identify any further remedies available for correction if concerned or desired.

- **Monitor:** The foundation exhibits evidence of prior bowing and cracking in various locations of the home. This is usually the result of excessive soil pressure on the foundation walls. The cracks appear to have been epoxy injection filled and the cracking does not appear to have increased in size since the repairs were performed. Refer to the documents available from the Seller describing the repairs performed.

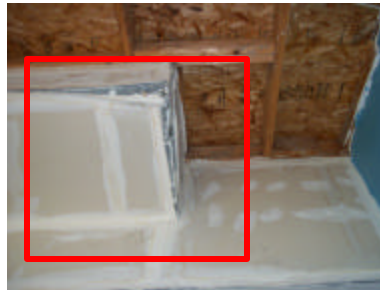
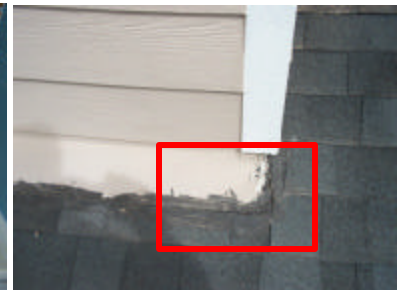
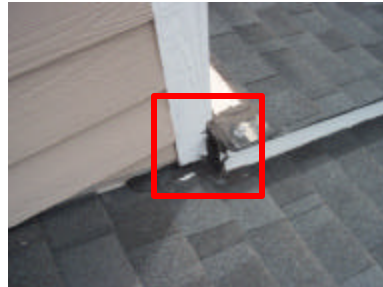
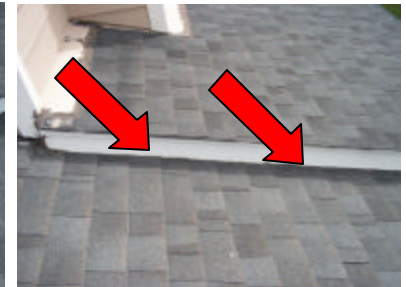
- **Monitor:** The wall flashing above the garage at the front wall should be kept well sealed. This flashing detail exhibits evidence of *prior* leakage and appears vulnerable to leakage.
- **Monitor:** The flashing on the south side of the garage should be carefully monitored. The proximity and configuration of this flashing is extremely vulnerable to leakage.
- **Monitor:** The clearance of the siding trim at the flashing on the southeast side of the garage is insufficient. This condition leaves the siding vulnerable to rot.

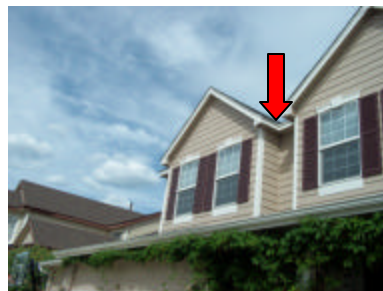
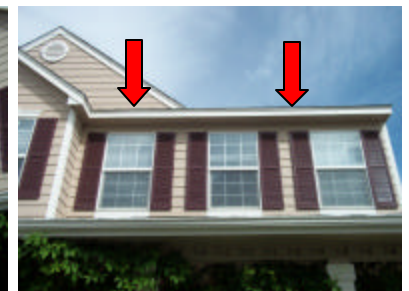
- ~~**Improve:** Loose or damaged downspouts on the garage should be repaired promptly. *This was proactively corrected by the Seller.*~~
- ~~**Improve:** The gutters at the lower front slope require cleaning. The "dirt" within the gutter is causing rust and may impede the flow of water to the downspout. *This was proactively corrected by the Seller.*~~
- **Monitor:** The gutters at the lower front slope do not appear to have sufficient slope to drain properly. *If they do not perform as intended, the slope should be adjusted.*
- **Monitor:** It is recommended that gutters and downspouts be installed at the upper front slopes.

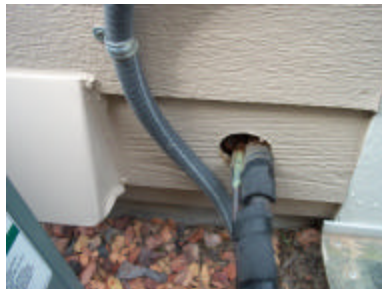
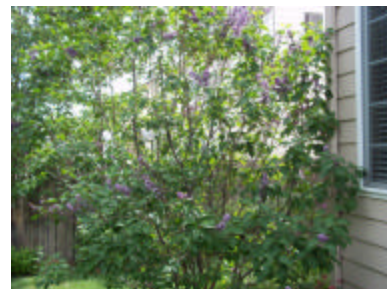
- **Improve:** Openings (seams) where the brick veneer meet the siding at the garage and the northeast corner should be caulked and sealed. *This was proactively corrected by the Seller.*
- **Improve:** Openings where the air conditioning liens penetrate the north wall should be better caulked and sealed. The existing condition can allow moisture to penetrate the composite siding and cause rot. *This was proactively corrected by the Seller.*
- **Improve:** Shrubbery branches at the northwest corner should be trimmed away from the house. *This was proactively corrected by the Seller.*
- **Monitor:** The exterior brickwork could be repointed (replacement of the mortar between the bricks) at the garage above the door headers and under the eave. *This was proactively corrected by the Seller.*

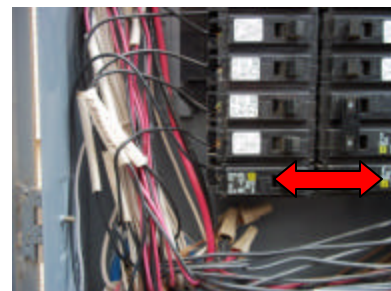
- **Improve:** Oversized breakers (20 Amps) at lug #39 & 40 within the main distribution panel should be replaced with 15 Amps breakers. All breakers should be appropriately sized according to wire gauge. *This was proactively corrected by the Seller. 15 Amp breakers were installed by a licensed electrician.*

- **Monitor:** Linking (sometimes referred to as bridging) should be provided wherever two fuses or breakers serve the same circuit as is the dishwasher and waste disposal. ***Notation from Electrician:*** “We have assessed and repaired the electrical concerns listed on the home inspection correction list. The issue noted regarding “bridging” of common linked circuits has been inspected and I do not recommend any repairs to this concern at this time. Linking or Bridging of circuit breakers on multi-wire circuits is a code requirement in the current 2008 Code, but was not required or enforced at the time of installation. In my opinion, this is a good practice, but does not present any major safety concerns.”
